Variance Petition

Rochester Housing Authority
Petitioner

Premises: 56 Holland Street
Rochester, NY 14605

Apartment Incidental Disturbance Cleanup

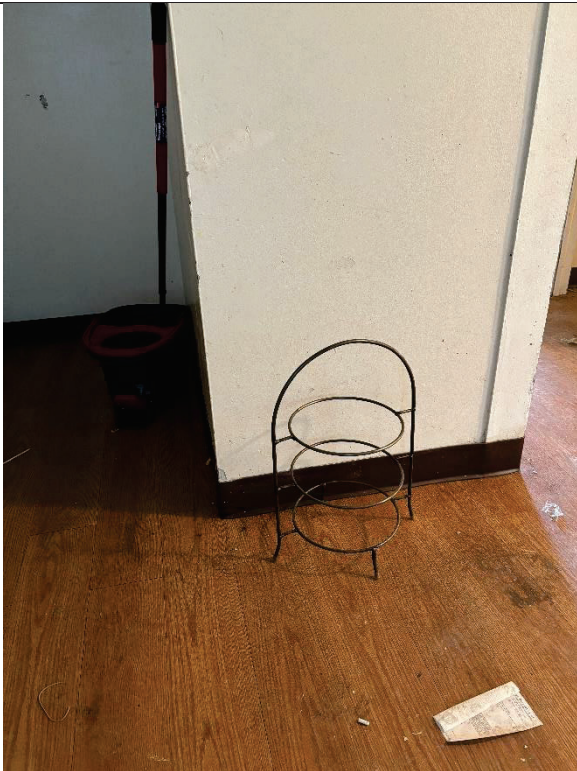
Photo 1

View of White Asbestos-Containing Joint Compound on Walls and Ceilings Throughout

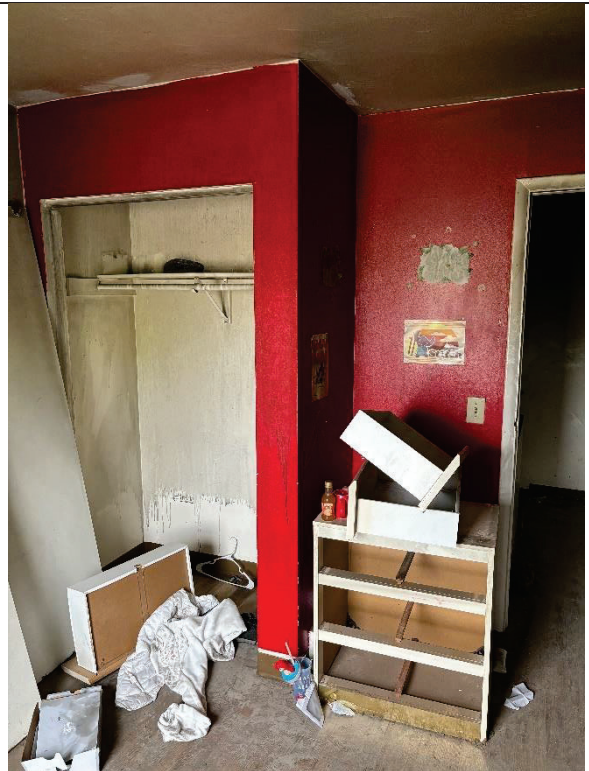
Photo 2

View of White Asbestos-Containing Joint Compound on Walls and Ceilings Throughout

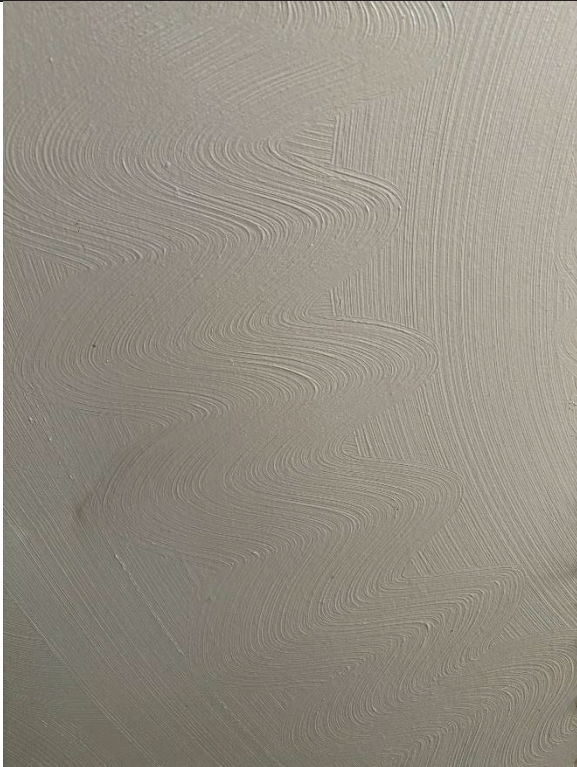
Photo 3

White asbestos-containing stucco is located on the ceilings throughout the inspected unit. The majority of ceiling stucco within the inspected spaces was observed to be in good condition. However, Rooms 1, 4 and 8 had extensive damage to the wall and ceiling systems caused by a recent fire within the unit. As such, ceiling stucco debris was observed throughout the impacted spaces.

View of White Asbestos-Containing Stucco on Ceilings Throughout

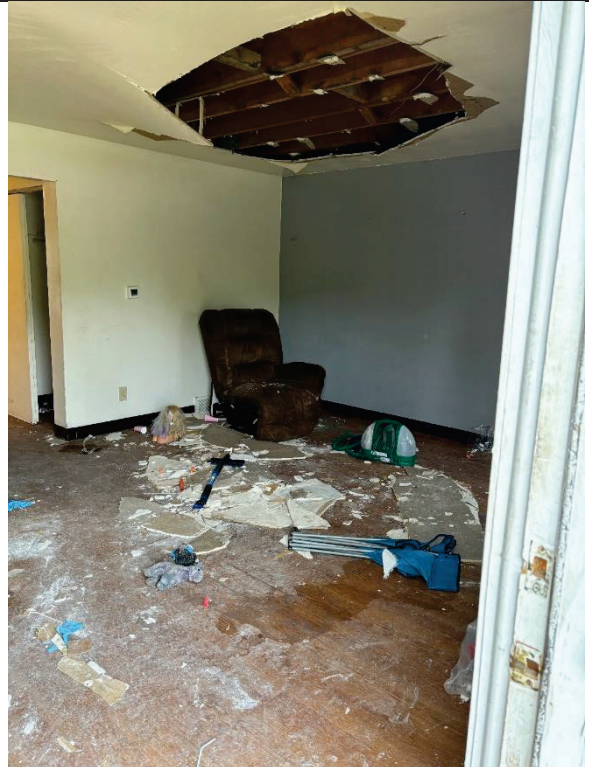
Photo 4

Additionally, the majority of joint compound within the inspected spaces was observed to be in good condition. However, Rooms 1, 4 and 8 had extensive damage to the wall and ceiling systems caused by a recent fire within the unit. As such, drywall/joint compound debris was observed throughout the impacted spaces.

View of Damaged Asbestos-Containing Joint Compound and Ceiling Stucco in Room 1

As stated earlier, the presence of damaged asbestos-containing materials were noted in several locations throughout the unit. These conditions represent an “Incidental Asbestos Disturbance” as defined by New York State Asbestos Regulations, (i.e., Industrial Code Rule 56). According to these regulations, personnel access to the areas affected shall be restricted until such time as the materials are cleaned up by a licensed asbestos abatement contractor. The clean-up of these materials shall take place as soon as possible.

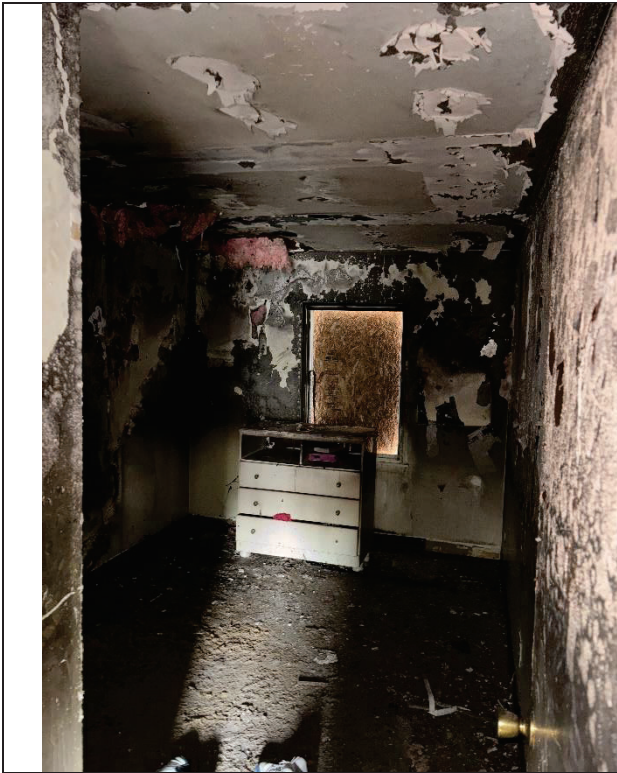
Photo 5

View of Damaged Asbestos-Containing Joint Compound and Ceiling Stucco in Room 4

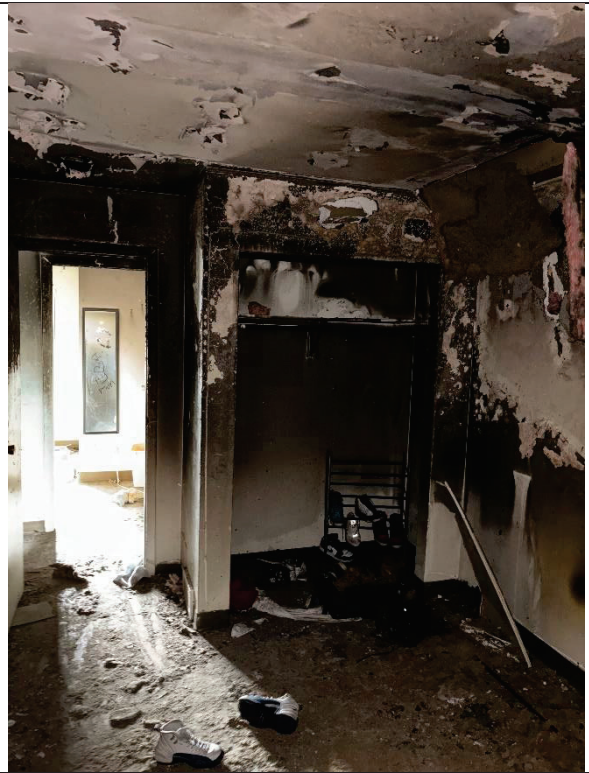
Photo 6

View of Damaged Asbestos-Containing Joint Compound and Ceiling Stucco in Room 4

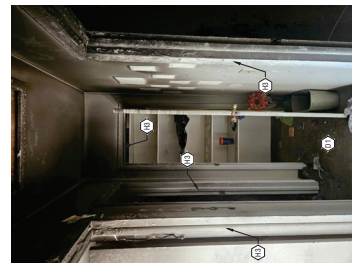
E VIEW OF DOOR CASINGS - HALLWAY

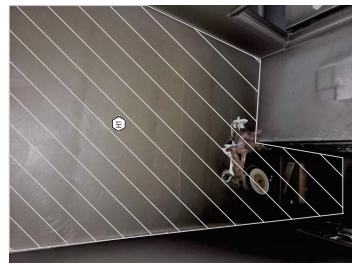
D VIEW OF CEILING GYPSUM BOARD - HALLWAY

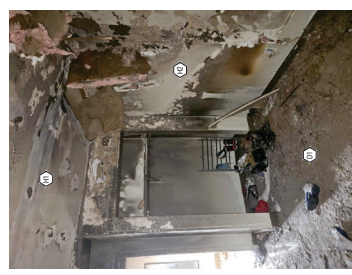
C VIEW OF GYPSUM BOARD - BEDROOM 1

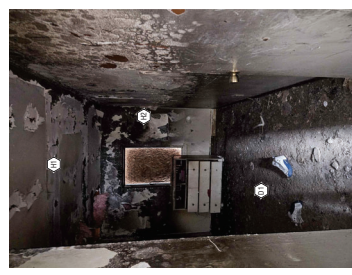
B VIEW OF GYPSUM BOARD - BEDROOM 1

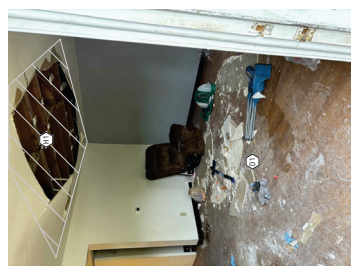
A VIEW OF GYPSUM BOARD/DEBRIS - LIVING ROOM
