Report Narrative

Jonathan Child Apartments Rochester, NY

Vertical Access LLC
PO Box 4135, Ithaca, NY 14852
Tel: 607 257 4049 / Fax: 607 257 2129

Vertical Access LLC (VA) was retained by the Rochester Housing Authority (RHA) to assist with the investigation of the Jonathan Child Apartments at 399 Colvin Street in Rochester, NY by performing a hands-on and close visual inspection of the exterior walls of the building. VA technicians utilized hammer sounding techniques and probed with hand tools as necessary to determine the condition of the building materials. Typical and notable conditions of deterioration were identified, documented, and quantified using digital still color photography keyed to annotated elevation drawings.

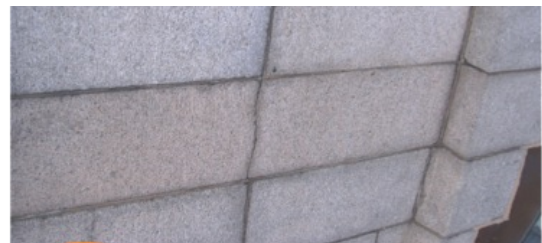
Use X-Y coordinates to match photographs to condition locations

Each survey photograph is named with a unique coordinate (not necessarily the beginning of the photo name) corresponding to its location on the drawing. Photo locations are referenced by their X-Y coordinates within the report narrative. If AutoCAD is not available, use the X-Y coordinates to match annotated conditions on the drawings to the corresponding photographs.

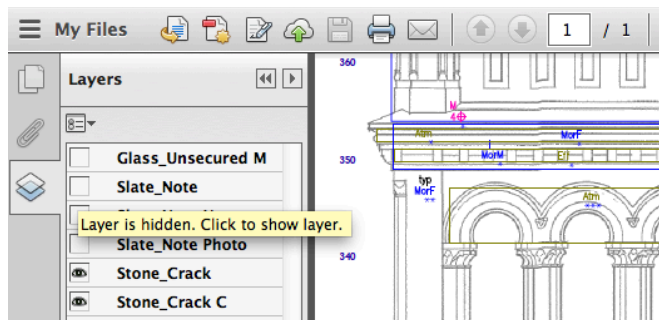
Manage layers in the PDF drawing for selective viewing and printing

All of the TPAS annotations are grouped together on layers named for each material and condition, and these layers can be turned on and off for ease of viewing. Open the PDF drawing in Adobe Reader to access the layer management panel. Print additional copies of the drawing showing only the selected layers, if desired. The PDF drawings may be printed full-size (typically 24" x 36") or reduced (CTB files are included to print at 11" x 17" with more legible line weights).

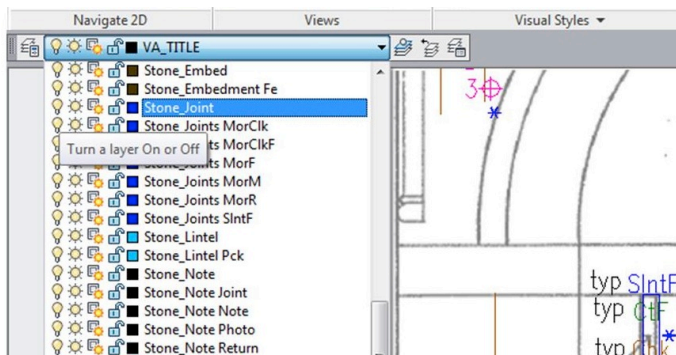
All of the TPAS annotations are grouped together on layers named for each material and condition, and these layers can be turned on and off for ease of viewing. Photo hyperlinks are on the same layer as the condition with which they are associated.

Use the AutoCAD Layer Manager to turn layers on and off, and to freeze and thaw layers: use the LAYER command, choose Layer from the Format menu, or click the layer button on the Object Properties Toolbar.

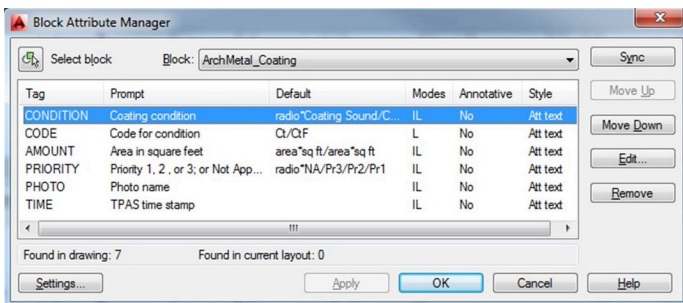
Global changes to blocks with attributes are made with the Block Editor, which accesses and edits block definitions. Launch the Block Editor from the command line—BEDIT, from the Ribbon: Home tab>Block panel>Block Editor, from the menubar: Tools>Block Editor or from the Modify II toolbar.

The Block Editor is not available in AutoCAD 2000/2002 or 2004. In those versions, use the Block Attribute Manager, which is launched from the command line—BATTMAN, the Modify menu: Modify>Object>Attribute>Block Attribute Manager or the Modify II toolbar.
