Bay-Zimmer Roof Replacement 2015

This family complex is located in the north eastern part of Rochester, nestled between a couple of secluded streets. Ten buildings include 16 two-bedroom, 16 three-bedroom, 10 four-bedroom, and 2 five-bedroom units. The roofs were replaced as part of the Rochester Housing Authority's Capital Improvement program.

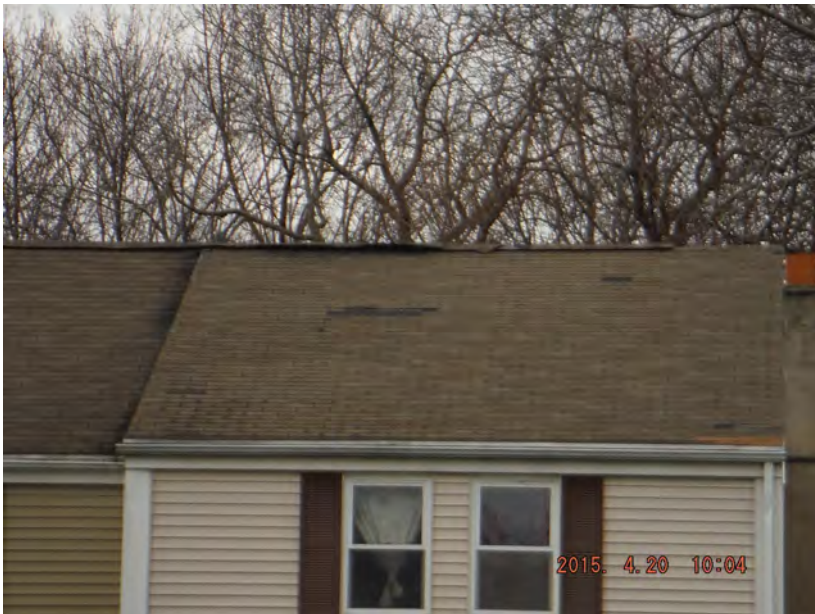
Before replacement, some gutters were damaged.

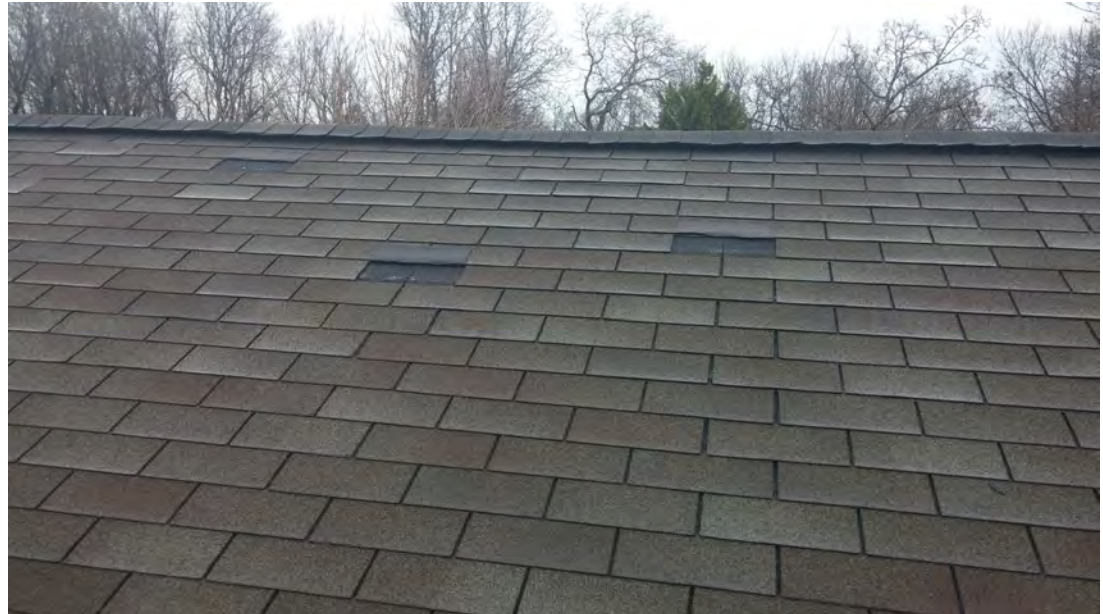
Before replacement, some shingles were missing.

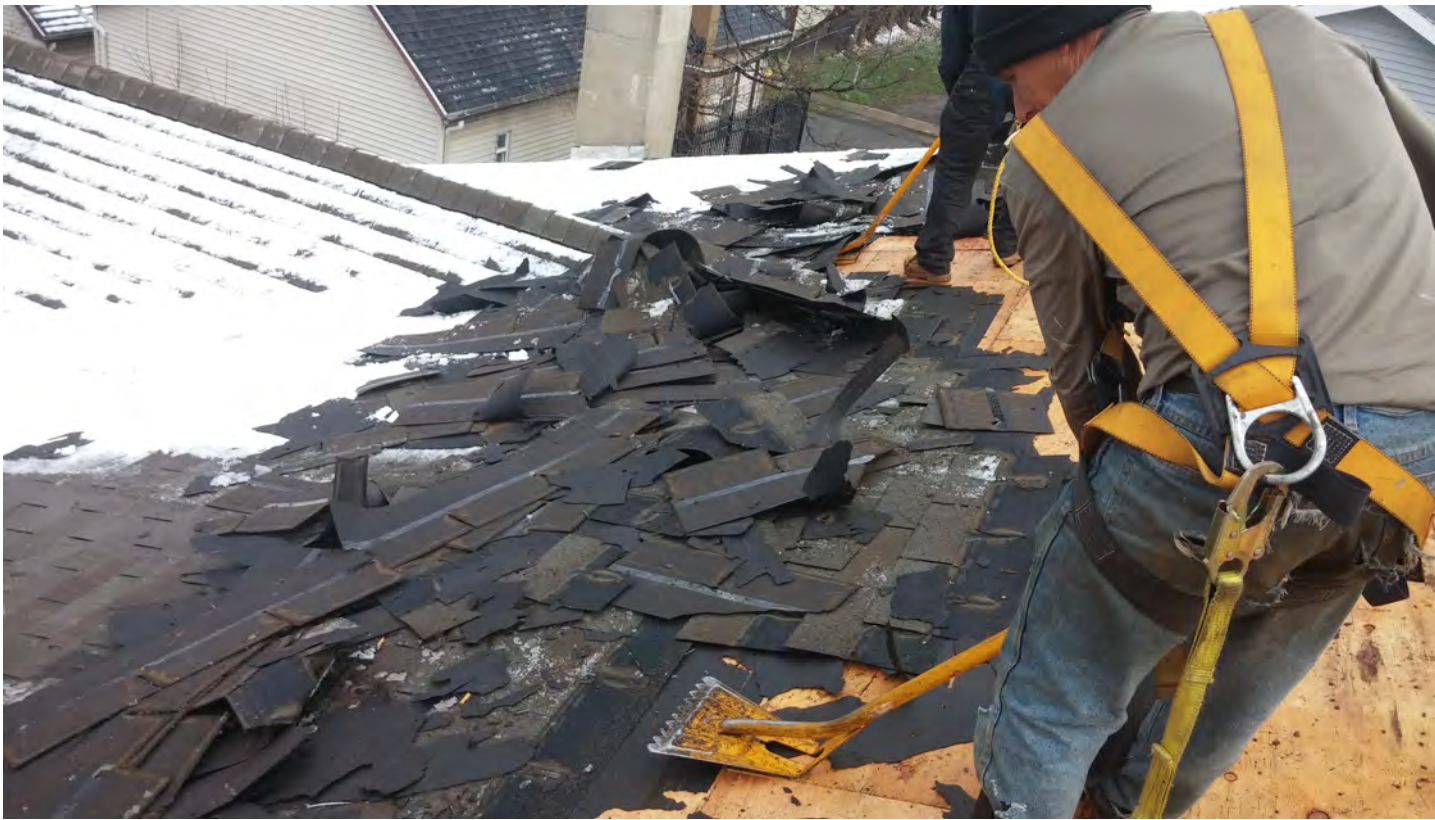
All shingles and underlayment is removed, plywood is inspected and replaced as needed.

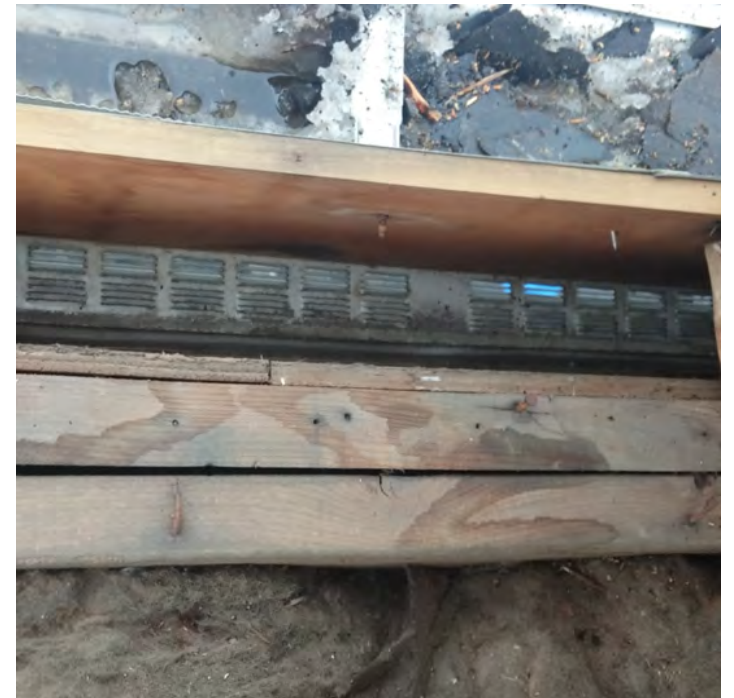
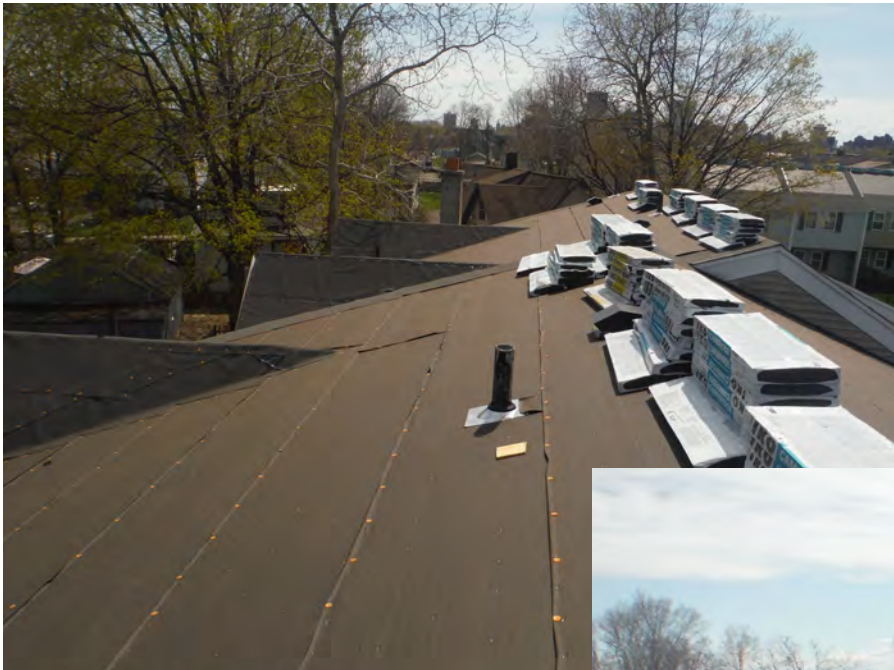
After tear-off, it was discovered that changes were needed to the fascia to provide adequate support for gutters and venting of roofs.

Proper venting, along with insulation, help prevent ice damning.

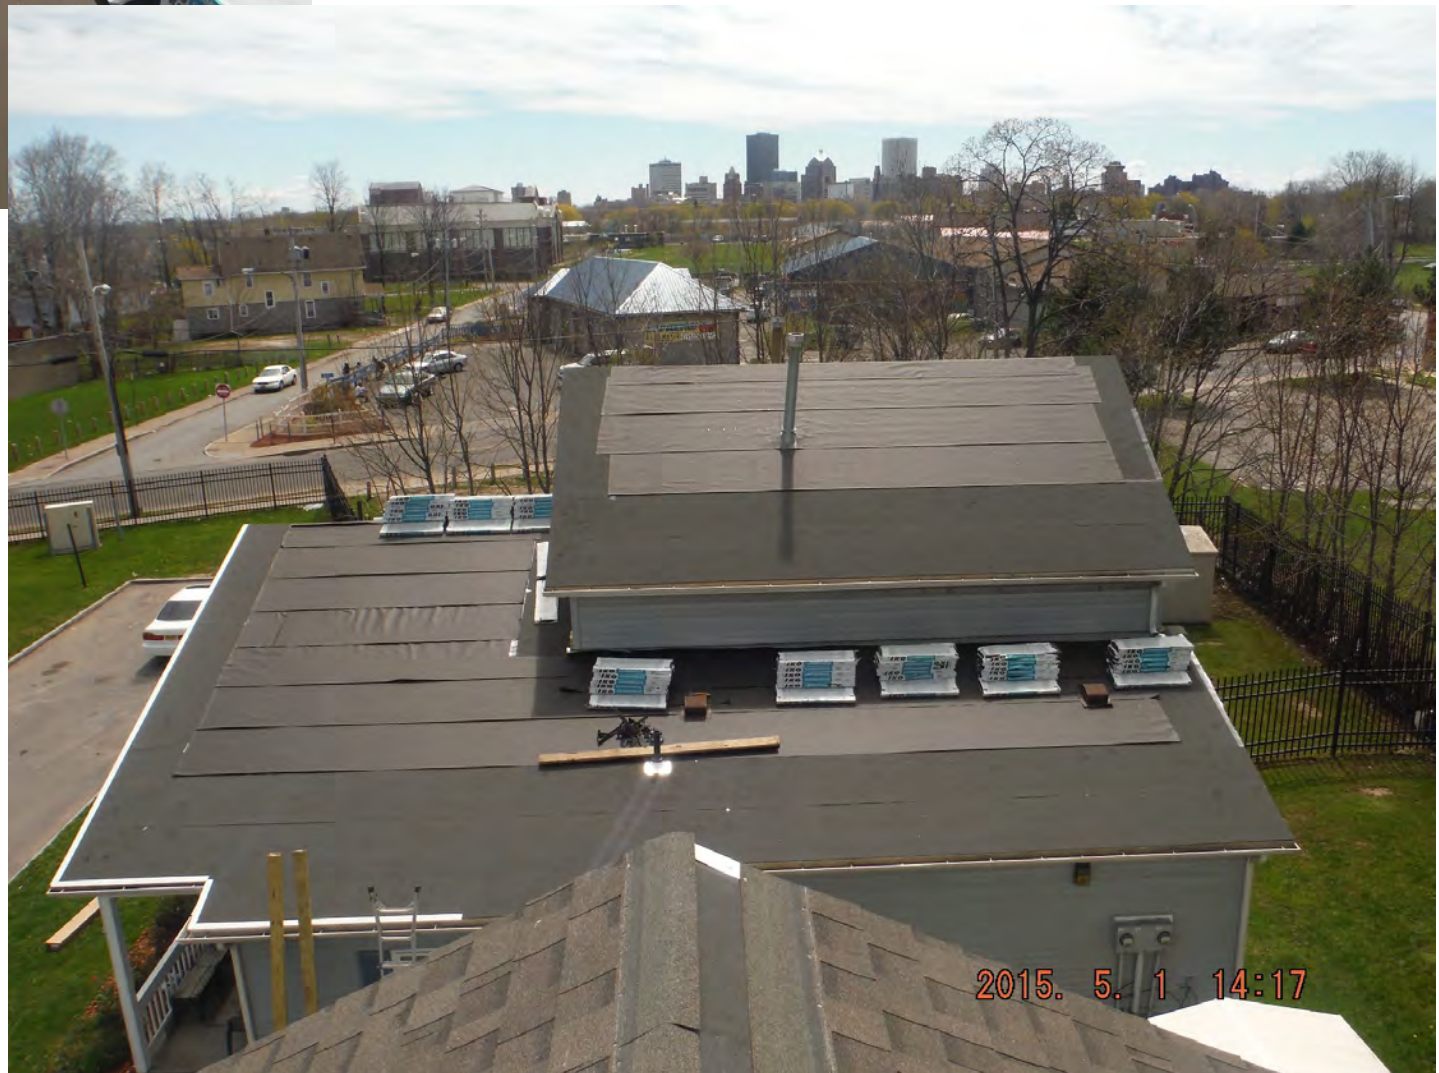
New felt paper installed.

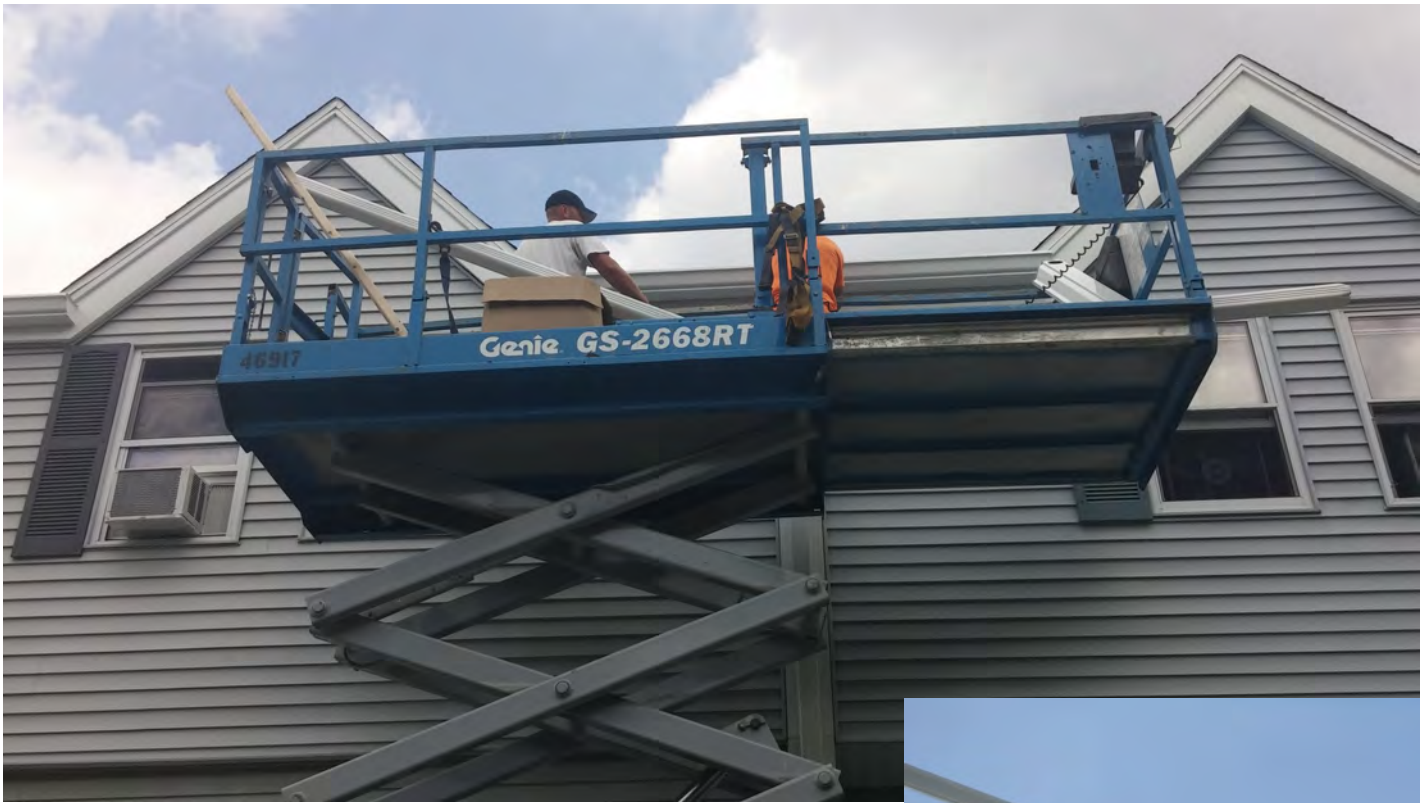
Water and ice shield was installed.

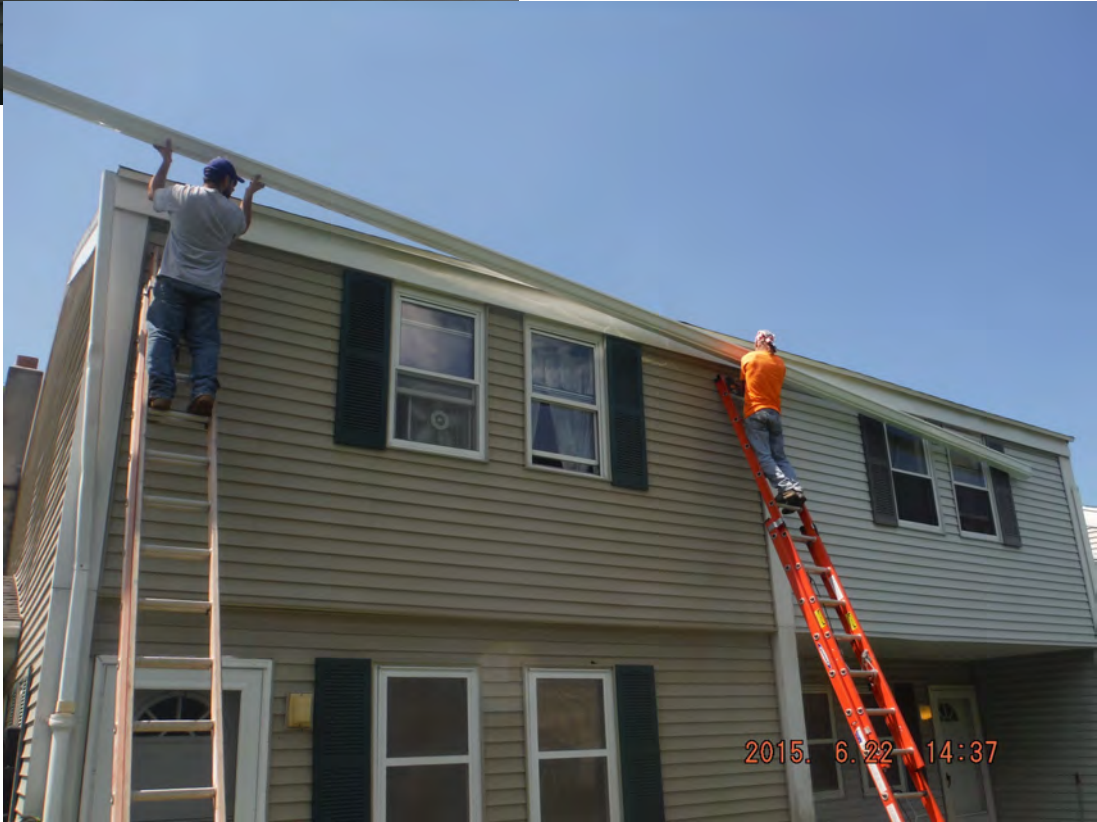
Installation of new gutters.

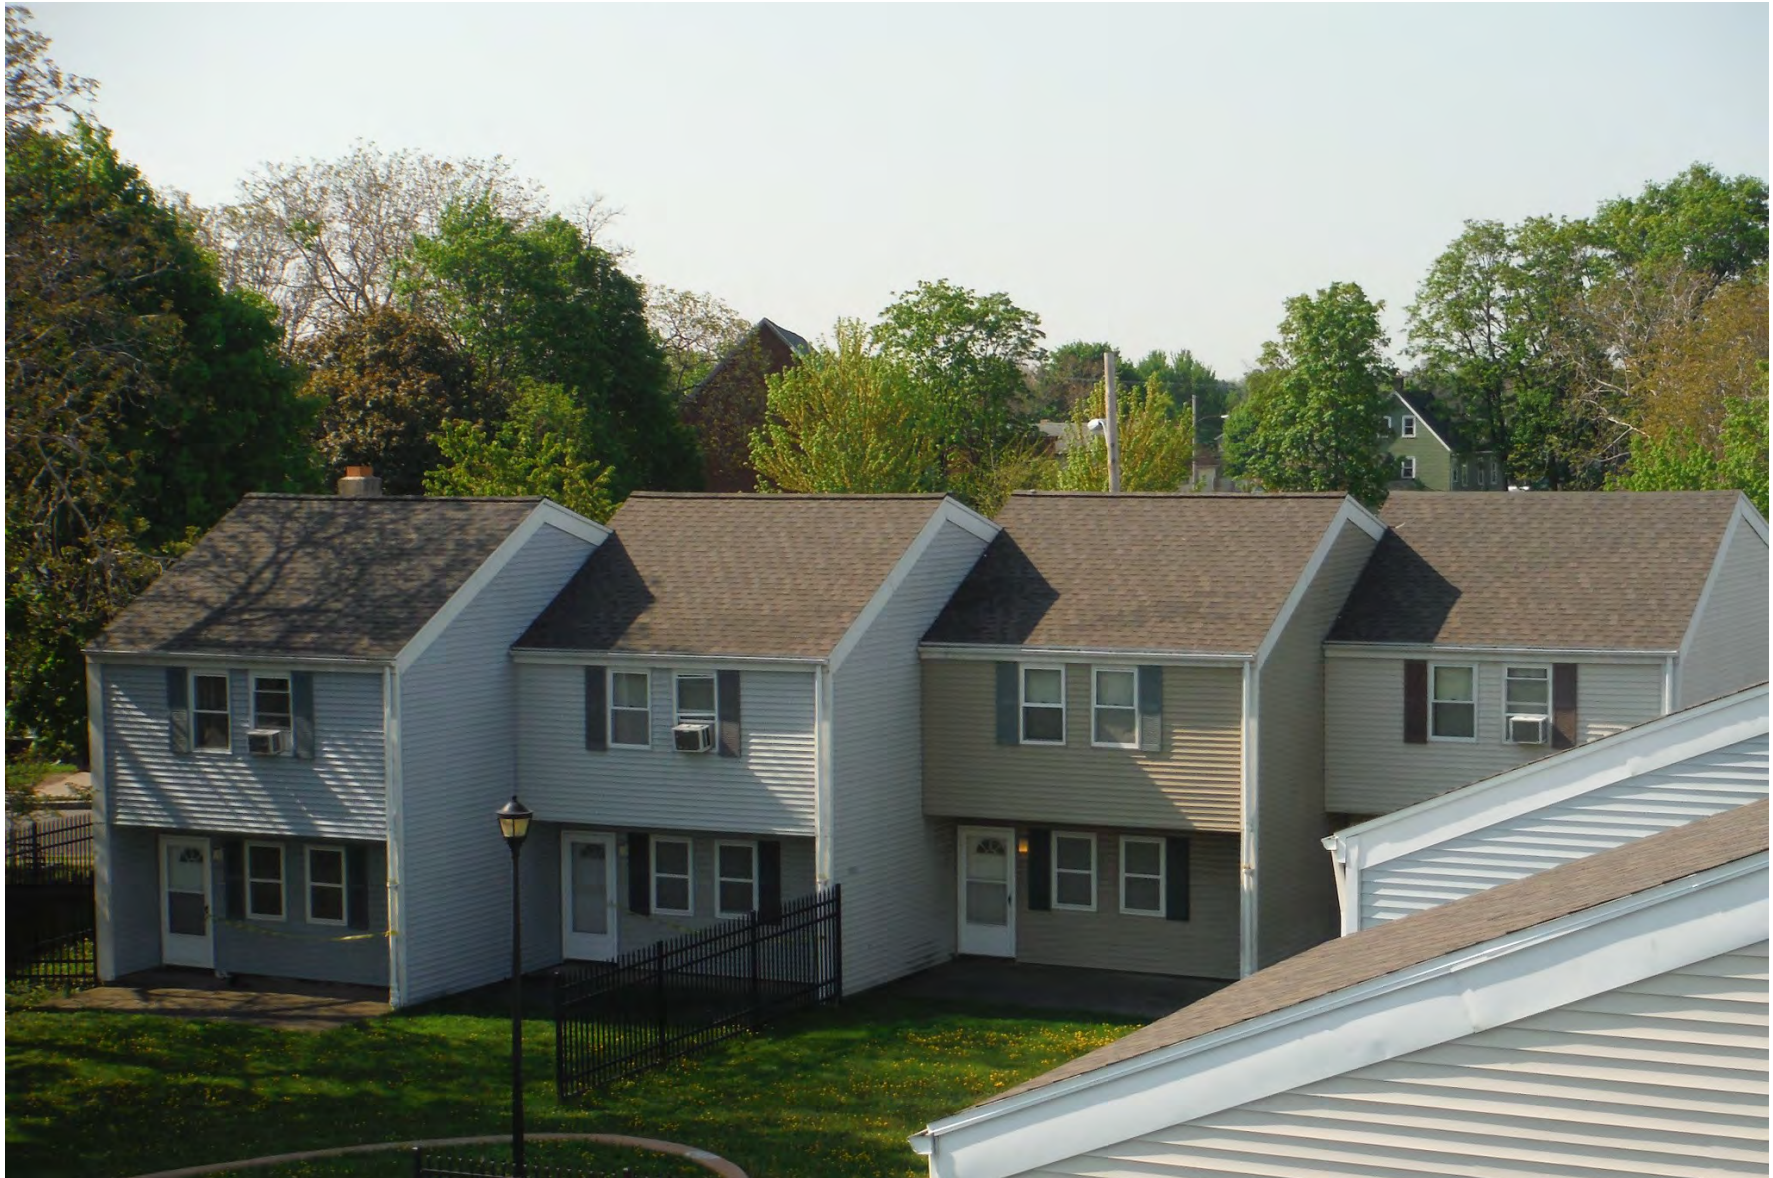
New 30-year shingles, ridge vents, gutters and downspouts installed.
